ALABAMA UNIFORM TRAFFIC CRASH REPORT

Local Case No. **BCSO Vehicle/Fatality**

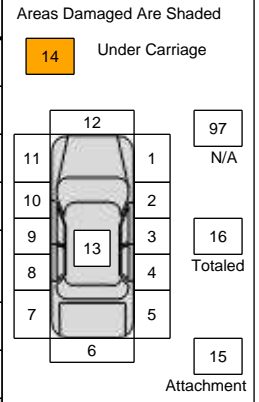
DRIVER	1	UNIT NO	Driver Full Name	Street Address				City and State				ZIP	35121	Telephone									
	DOB	Month	Day	Year	Race	1	Sex	1	DL State	AL	Driver License No.	DL Class	D	DL Status	C	Restrict Violations	97	CDL Status	97	Endorse Violations	97		
	Place of Employment	Blount County Sheriffs Office Oneonta AL										Residence Less Than 25 Miles	Yes										
	Liability Insurance Co.	Self Insured				Liability Policy No.				97				Insurance NAIC Number	N/A								
	Driver Condition	1	Sobriety/ Officer Opinion	Alcohol: No Drugs: No		Type Alcohol Test Given	6		Alcohol Test Results	N/A		Type Drug Test Given	4		Drug Test Results	97		Maneuver	1				
	Most Harmful Event for MV	31		Travel Road Name				2nd Avenue		Road Code	5012		Travel Direction	4		Unit Contributing Circumstance	97		Total Injuries in Unit	0			
	Sequence of Events	31		Event 2		97		Event 3		97		Event 4		97		First Harmful Event Location	1		Areas Damaged Are Shaded

On 3/28/2023, the reporting Trooper traveled to the scene and took photographs of the area. He then traveled to the Blount County Sheriff's Office where Unit 1 was inspected and photographed. After inspecting Unit 1 and documenting the area of damage, it is the opinion of the reporting Trooper that at the time Unit 1 was crossing over the cable, that it was being manipulated in some manner.

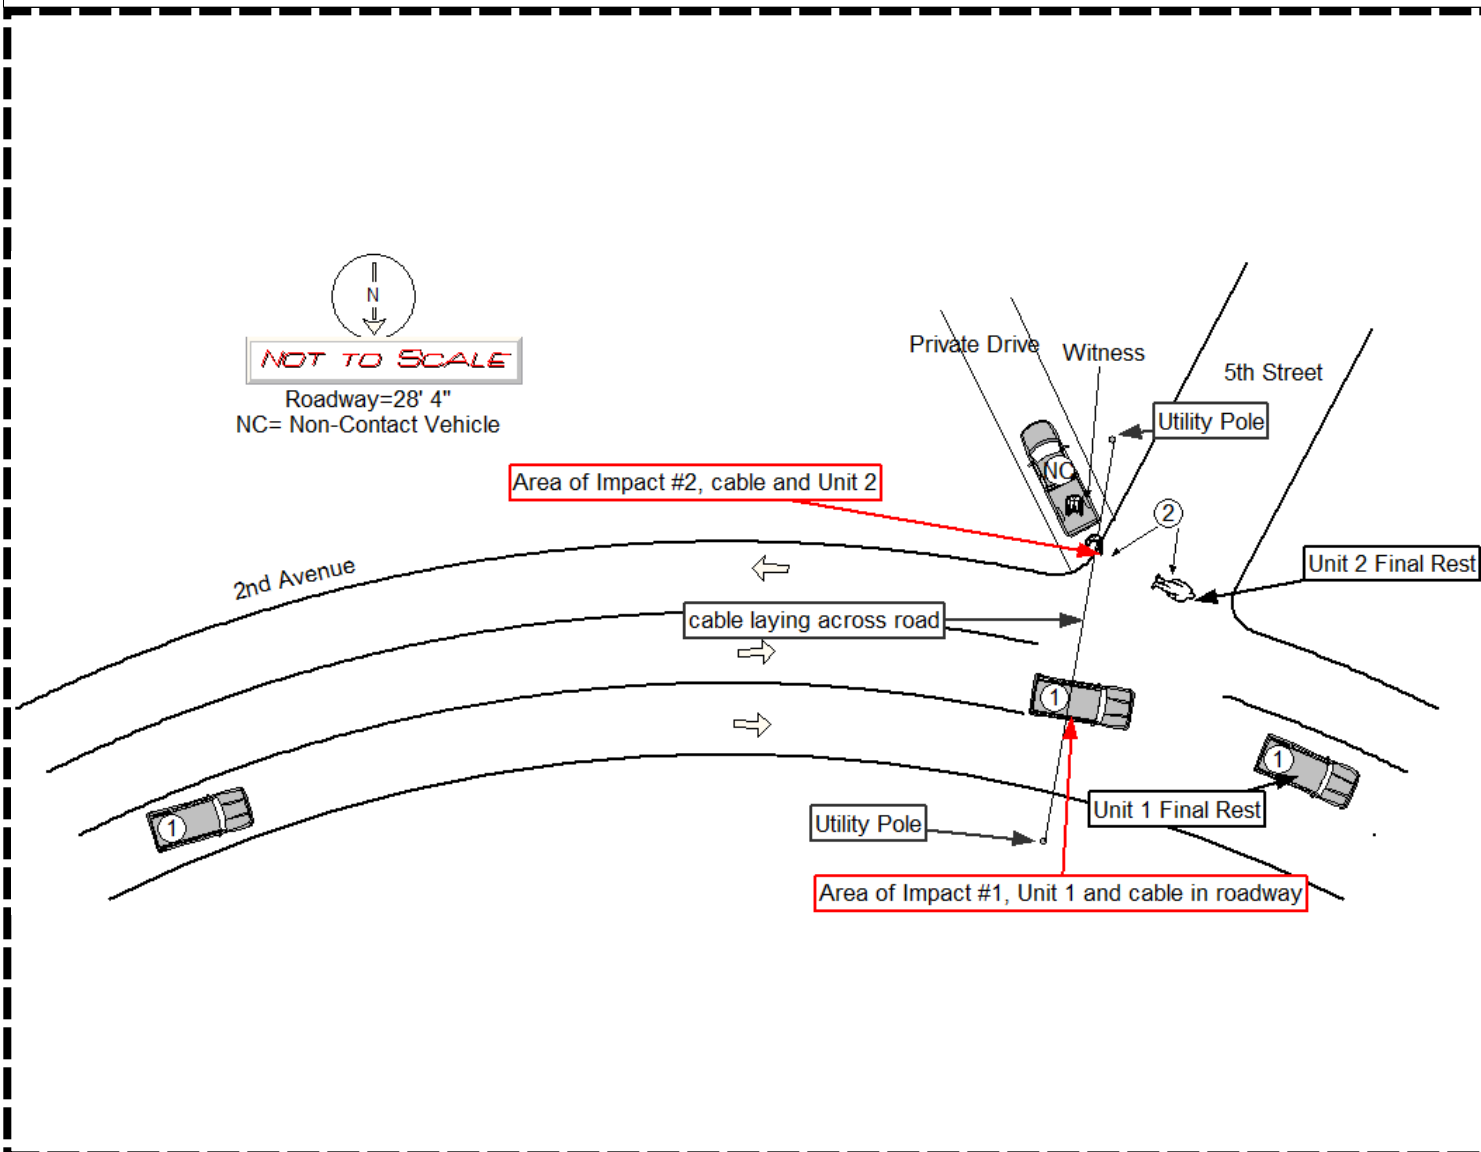
DIAGRAM

Unit 1, which was a Blount County Sheriff's Patrol Vehicle, was traveling west on 2nd Avenue. Unit 2, which was a pedestrian, was standing at the rear of a non-contact bucket truck attempting to repair a cable that had been damaged and was lying across Second Avenue. Unit 2 (pedestrian) was working at the rear of a non-contact bucket truck attempting to repair a cable that had been damaged and was lying across Second Avenue. The cable got hung on the undercarriage of Unit 1. After being struck by Unit 1 the cable was pulled over the hood striking Unit 2 who was standing between the cable and the bucket truck. The tension on the cable knocked Unit 2 violently to the ground in the intersection.

The driver of Unit 1 stated that he saw the cable in the ditch to his right so he got over to the left a little and that is when he felt the rear of his vehicle rise and come to a stop. There were no warning signs, flags, or any other traffic control to warn traffic of the temporary work zone or cable that was lying across

the road. A traffic camera near Hayden Middle School captured the crash event. The witness, who was also working to repair the damaged cable stated that he was in the bucket fixing to go up to stretch the new cable across the road and Andrew(Unit 2) was standing at the bucket, next to the cable, handing him tools when Unit 1 struck the cable in the road.
